Addendum No.: 3

Project Name: Covington Library Renovation

Limited Mold Assessment Report

St. Tammany Parish Library Covington Branch Library August 20, 2018 SEMS Project No.: 1008-0001

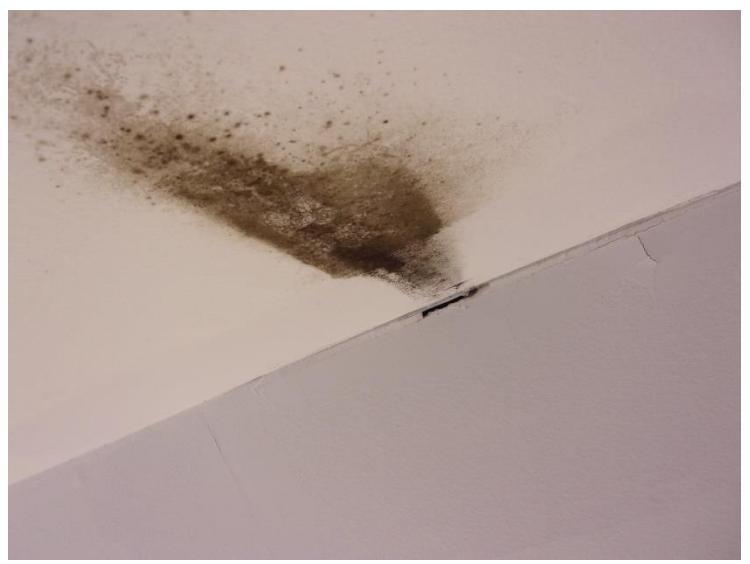
Visual observation of the main library area which is designated as the complaint area, showed approximately 50 square feet of suspected surface mold growth on the vaulted ceilings. This growth was occurring at places where the caulking at the apex of the ceiling was deteriorated or missing which allowed hot air from the building exterior to condense when it met the cool air in the building interior.

View of visible mold growth sampled as 1008-0001-02

- Fix missing or deteriorated caulk in vaulted ceiling area of the building in order to prevent surface mold from re-occuring
- Continue to change HVAC filters every 4 weeks
- Following planned renovation, have HVAC balanced and serviced by licensed HVAC technician.

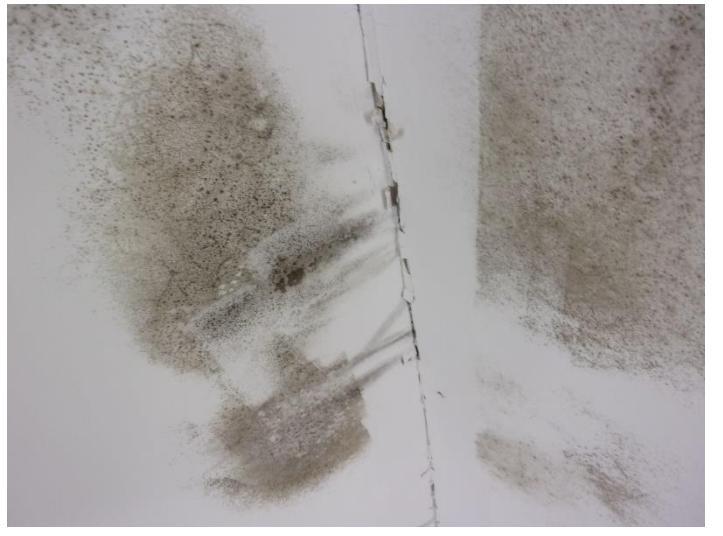
View of visible mold growth sampled as 1008-0001-01

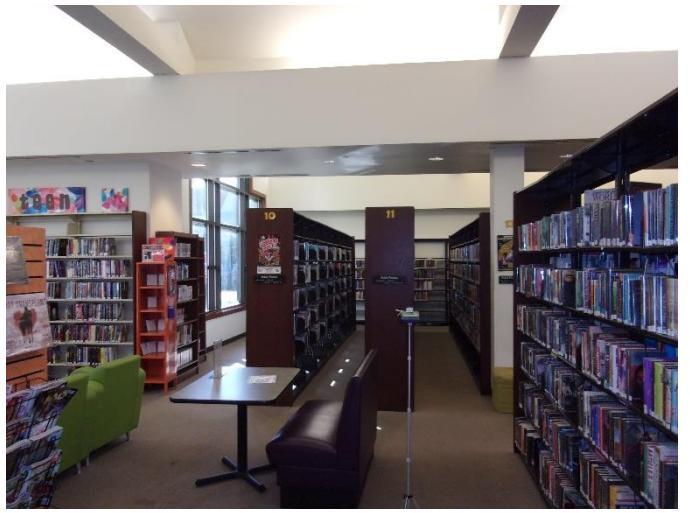
View of sample 1008-0001-04 complaint area

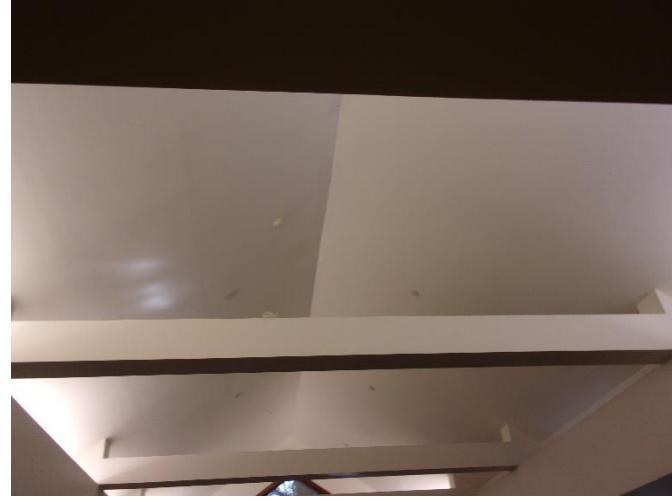
View of complaint area ceiling with no visible mold
